Outdoor Laboratory and Testbed for Bridge Health

Richard L. Wood (PI); Mitra Nasimi, Bowen Yang, Christine E. Wittich (co-PI); Joshua S. Steelman (co-PI); Jay A. Puckett (co-PI); Daniel G. Linzell (co-PI); Jinying Zhu (co-PI), Mohammad Ebrahim Mohammadi

University of Nebraska-Lincoln

June 2022

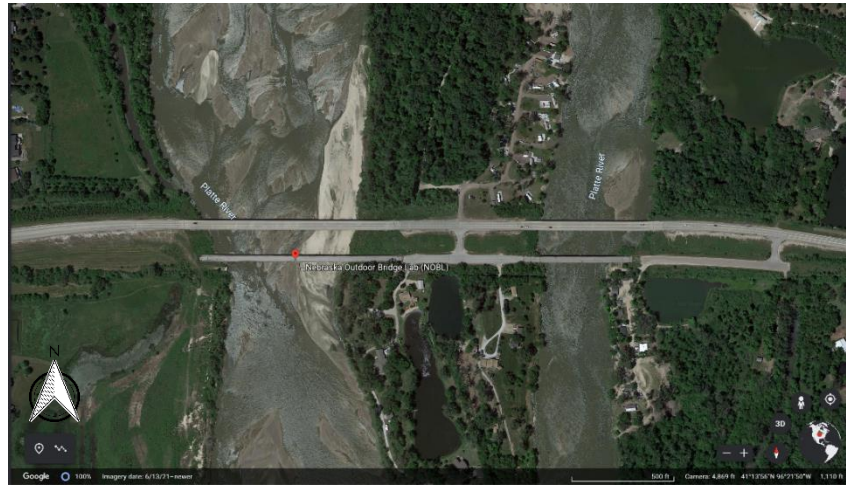
Figure 2.1. Site view of NOBL lab at Yutan.

The (primary) NOBL site is located on Nebraska State Route 92 over the Platte River just east of Yutan, as shown in Figure 2.1. Herein, this is known as the “Yutan (steel) bridge site”. At this site, two steel girder bridges cross the river in two separate crossings (with an island). These bridges were decommissioned in 2005 when replacement bridges were constructed just to the north of the bridge lab.

(a) Detailed view of NOBL lab at Yutan

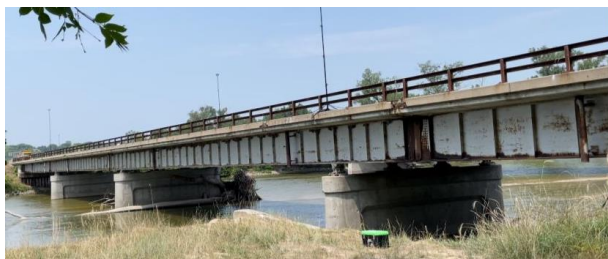
Figure 2.2. Yutan Steel bridge.

These bridges have nominal lengths of 400-feet (east bridge) and 1000-feet (west bridge). Overview photos of the bridges are illustrated in Figure 2.2. As illustrated in Figure 2.3, these steel bridges exhibit various damage mechanisms due to environmental and mechanical loads. This includes steel girder corrosion, abutment cracking, anticipated concrete delamination, and cracking in the asphalt overlay. The east bridge consists of (4) 100-foot spans comprised of approximately 54-inch welded plate girders with pin and hanger connections. The west bridge consists of eight 112-foot spans comprised of approximately 54-inch welded plate girders with pin and hanger connections. Both bridges at this site were designed in 1960. Information, structure numbers, and properties for both steel bridges at Yutan are summarized in Table 2.1.

(a) NOBL East bridge at Yutan overview (NOBL East)

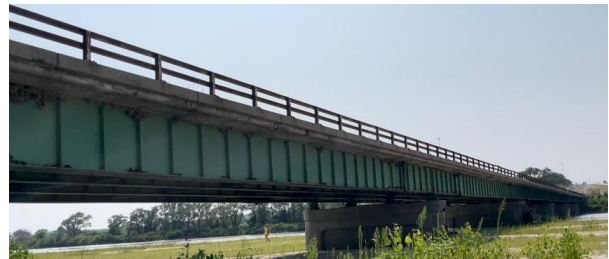
(b) Yutan west steel bridge overview (NOBL West)

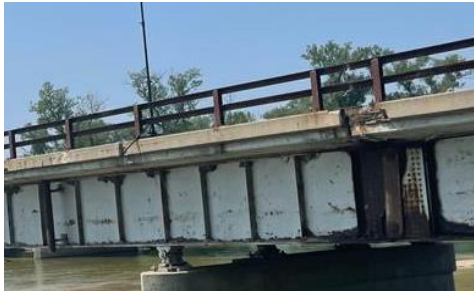
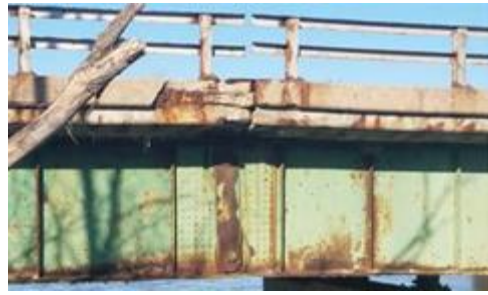
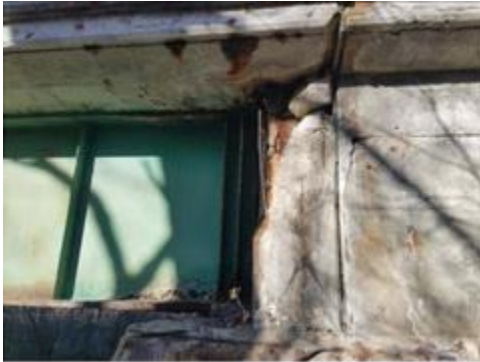
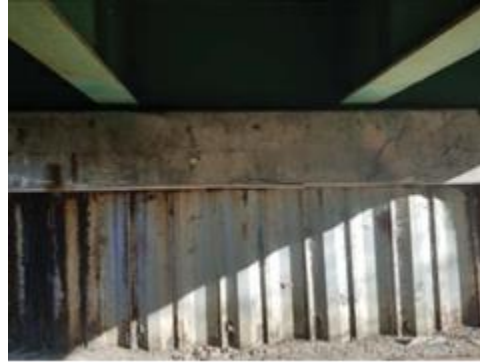
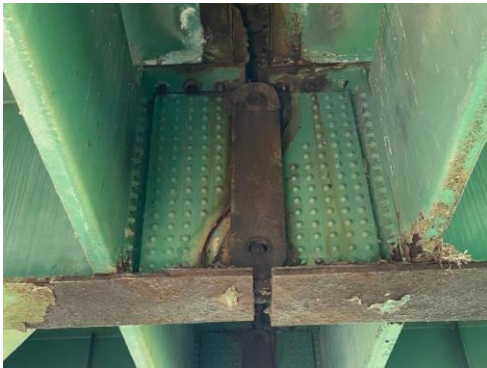
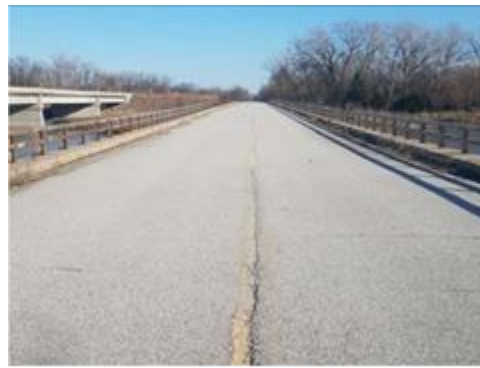
Figure 2.3. Example images of the steel girder bridge damages at Yutan bridge site.

(a) Example corrosion and delamination

(b) Abutment damage

(c) Pin lost at pin-hanger connection

(d) bridge deck with cracking

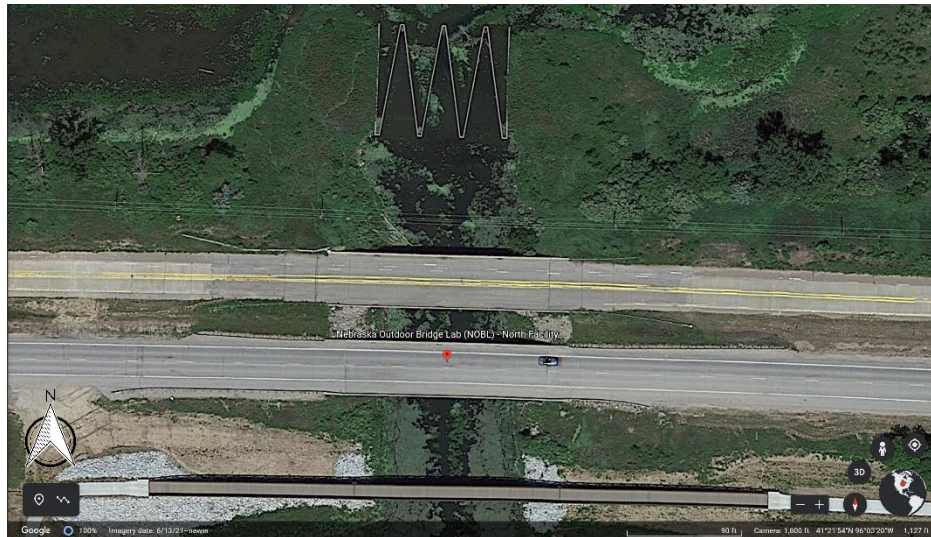
Figure 2.4. Site view of NOBL North bridge in Omaha .

The (other) bridge site is located on State Route 36 over the Glenn Cunningham Reservoir just north of Omaha, as shown in Figure 2.4. Herein this is known as the “Omaha (concrete) bridge site” or “NOBL

(a) Detailed view of NOBL North bridge in Omaha

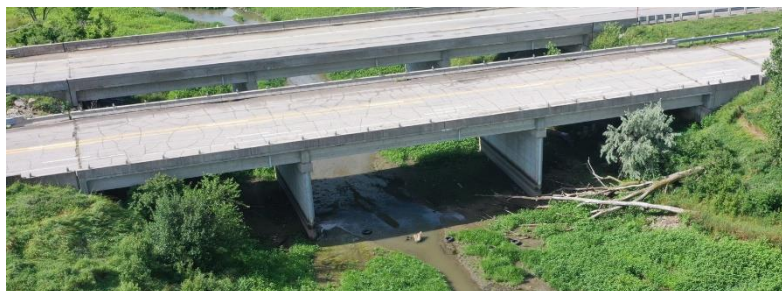
North”. This concrete bridge was originally designed for a potential four-lane divided highway expansion in 1979, but has seen only minimal traffic loads. This bridge site does experience occasional traffic associated with recreational users (e.g., horseback vehicles), training exercises (e.g., NDOT, Omaha Police Department, etc.), and construction traffic (as in 2022). The concrete bridge at Omaha consists of three spans (as shown in Figure 2.5) of 48, 60, and 48-feet, respectively; and is comprised of AASHTO girder type 3A (Shown in Figure 2.6). This bridge was designed in 1979 as a pair, at the time of construction, this bridge was one of the twenty bridges that received an asphalt with waterproofing membrane on the original construction and before opening to service. Now the north pair of the bridge is unused while the south pair of the bridge has supported regular traffic of Nebraska State Highway 36 since construction. As illustrated in Figure 2.7, various damage modes can be observed in this structure despite its minimal use of mechanical loads (vehicles) as well as environmental loads. This includes localized scour at the abutment, abutment cracking, suspected delamination near the bridge deck weep holes, and cracks in the asphalt deck overlay. Information, structure number, and properties for this bridge are summarized in Table 2.1

Figure 2.5. Overview of the NOBL North bridge in Omaha .

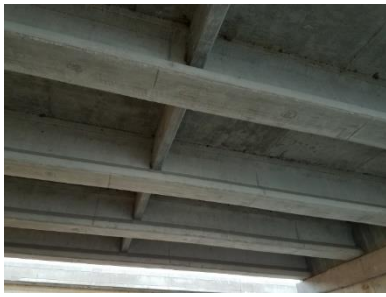
(b) View of concrete girders from below

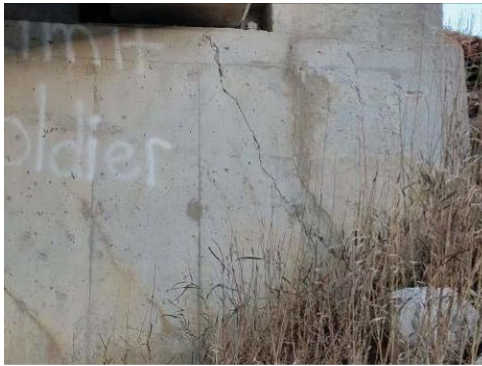
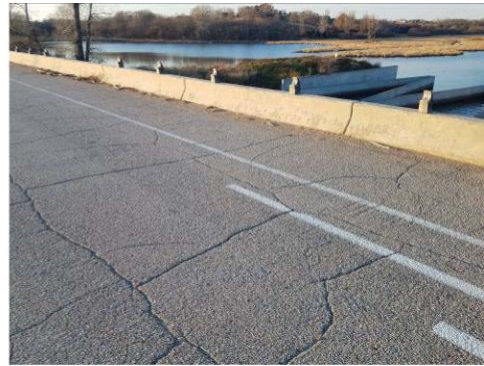
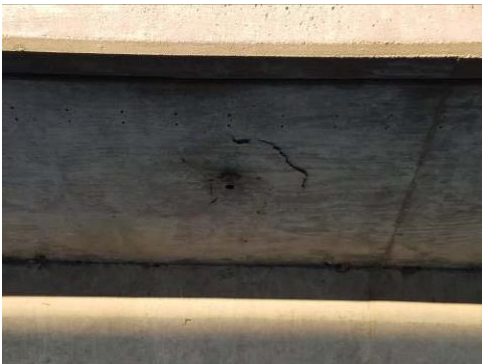
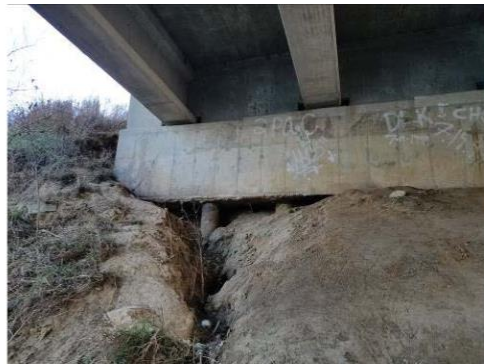
Figure 2.7. Damage example images of the NOBL North bridge in Omaha site.

(a) Abutment Damage

(b) Bridge deck condition with cracks

(c) Delamination at weep hole

(d) East abutment damage and exposed pile

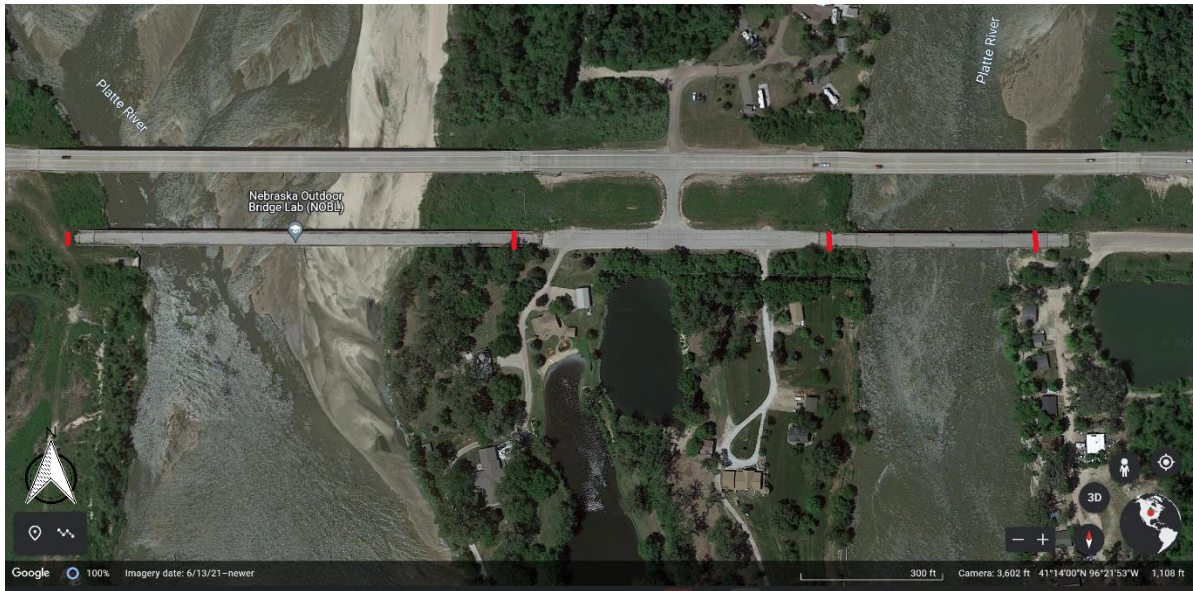
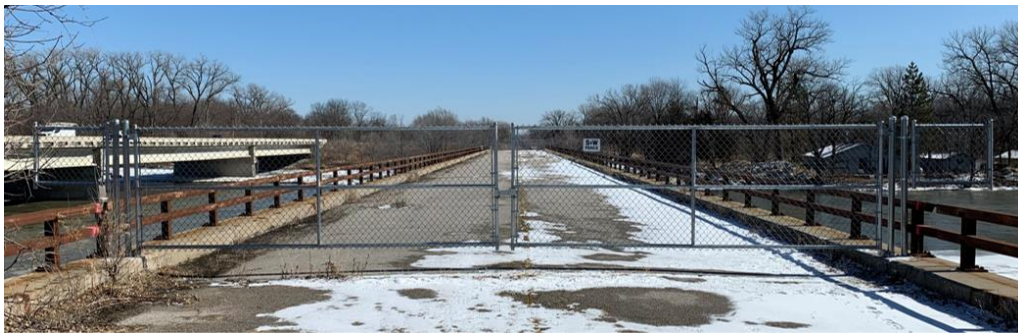
Figure 2.8. Detailed information of the gates placed in NOBL lab at Yutan.

(a) Gate locations in NOBL lab at Yutan

(b) Gate C detailed view

(c) Geometric information of gates

At Yutan, these bridges are in close proximity to routine traffic loads (Nebraska State Route 92) as well as see occasional and unapproved recreational uses, despite both of these two bridges at Yutan posted for no trespassing. Fencing gates are installed at this site for safety and limit access for personnel and equipment uses at this site, as part of this project. The purpose of these gates is to create a safe laboratory environment for both the UNL/NDOT participants, their invited guests, and the public as well as permit access by approved personnel. To accomplish this, fencing was installed to limit access to the general public and traffic. Access to open these gates is controlled by a state-owned padlock (with a key for DOT and other state agencies' access (e.g., Nebraska State Patrol)) and a numeric combination lock (for NOBL uses). Figure 2.8 shows the location and details of each of the abutments of the NOBL facility at Yutan. The official signature for the facility exists on both Yutan bridges. Moreover, no fencing or gates were placed at the NOBL North site in Omaha.

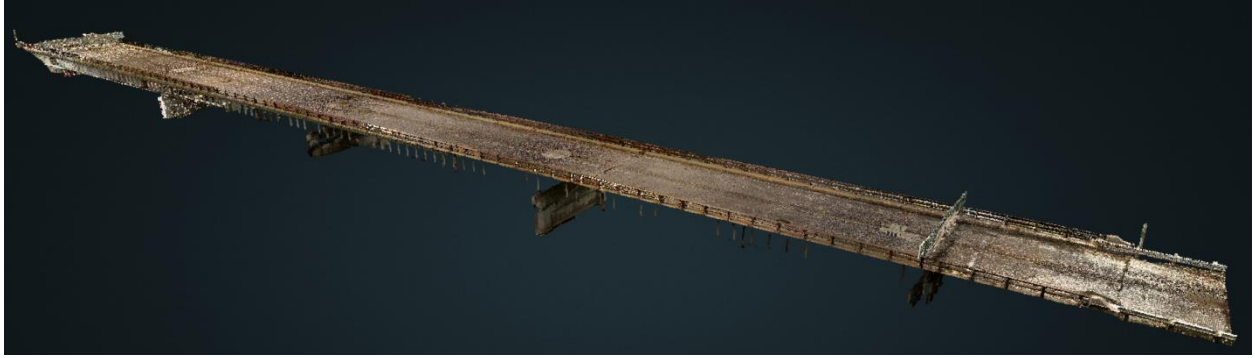
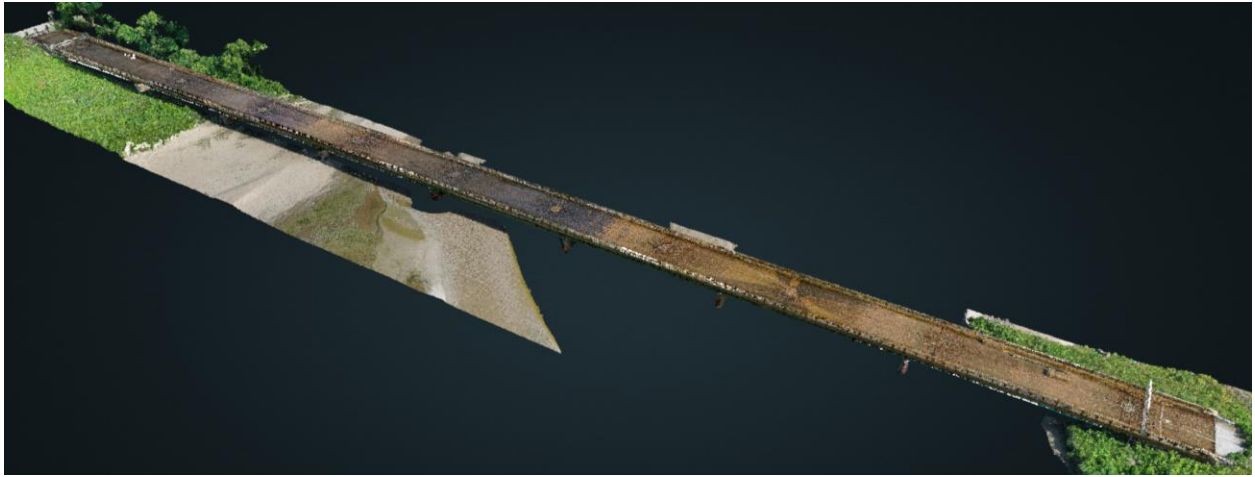
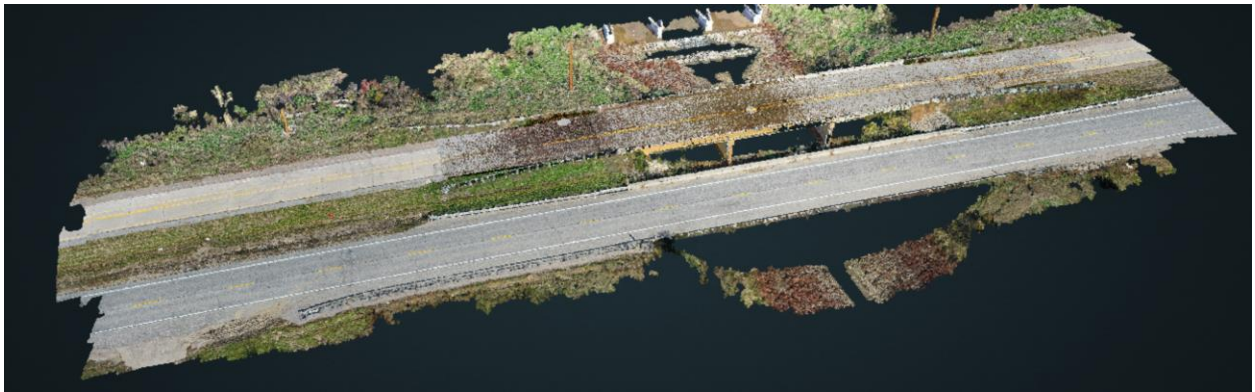
Figure 3.1. Point clouds for the three selected bridge sites.

(a) NOBL East steel bridge at Yutan (NOBL East)

(b) NOBL West steel bridge at Yutan (NOBL West)

(c) NOBL North concrete bridge in Omaha (NOBL North)

Light detection and ranging (lidar) scans were collected using two scanners, Faro Focus^{3D} X130 and S350 laser scanners, for each bridge structure. The Faro Focus^{3D} X130 lidar or laser scanner and Faro focus S350 laser scanner was utilized during the site investigations and are used to scan profiles in distance ranging up to 130 (426 [ft]) and 350 (1148 [ft]) meters, respectively. For terrestrial-based scanning, multiple scans at various locations with adequate overlap are required to create a dense point cloud, reduce areas of occlusions, and improve the alignment accuracy. These points aid in quantifying the static geometry of the bridges. One delay during the project did arise in the field deployment of the S350 lidar scanner. This sustained damage in the field at the NOBL North site given traffic-induced wind but was successfully repaired after an unfortunate and extended delay.

The lidar scan files are uploaded into various computer software platforms, such as Faro Scene, Cloudcompare, and Autodesk Recap, for point cloud processing for take-off geometry. Each individual scan file contains inherent noise, which is unavoidable. Most of these points are removed with segmentation (manually) and filtering techniques. A statistical outlier removal (SOR) filter is used to eliminate most of

the noise and erroneous points with automation, especially those caused by sharp object edges. This filter estimates the mean distance between the inputted number of random points and removes the points outside of the specified standard deviation threshold. Filtered point clouds provide accurate information about the geometric information and could use for further comparison purposes as the bridge condition changes.

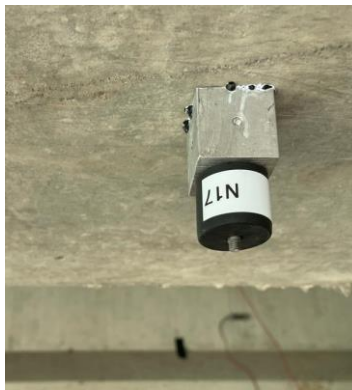
Figure 4.1. Example placement of a wired uniaxial accelerometer.

To collect data during the field experiments a series of cabled uniaxial sensors were used to record the bridge vibration response of the bridge system under various load patterns. The uniaxial sensors are wired piezoelectric accelerometers, shown in Figure 4.1. The PCB 393B04 accelerometers have a measurement range of $\pm 5g$ and a broadband resolution of $3 \times 10 \mu g$ root mean square (RMS). This type of sensor is a high-sensitivity seismic accelerometer that is extremely sensitive to indiscernible vibrations. It has been successfully used on bridge structures in the past, but is heavily used and validated in the NDOT Inverted Tee Project (Martindale, et al., 2019). This sensor collected data at a sampling frequency of 2096 Hz, which provided ample frequency resolution for post-processing to quantify the bridge response reliably.

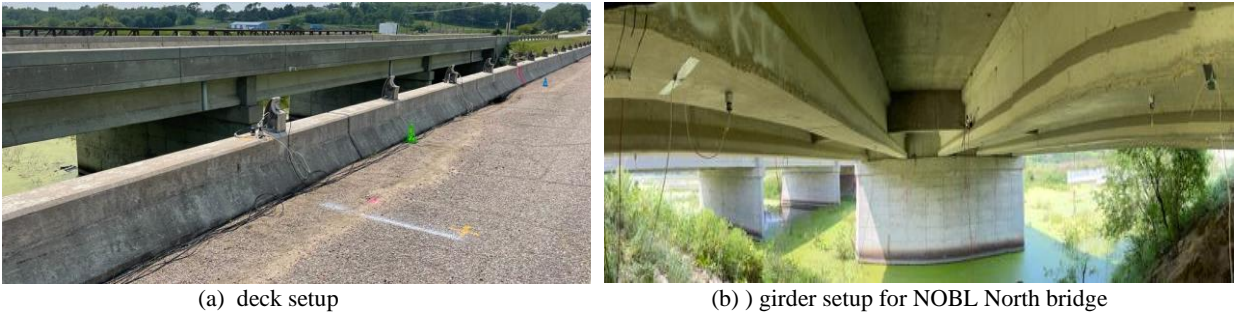
Figure 4.2. Field accelerometer instrumentations as placed for NOBL North.

During the field experiments, accelerometers are attached to the top portion of the deck of the bridge in each span at 1/3 points along the length. Figure 4.2 shows example instrumentation for NOBL North bridge. For this type of setup, accelerometers are typically placed in opposing pairs on the deck curb (north and south curbs on the deck). The deck setup for NOBL North is shown in Figure 4.3. An assembly of the

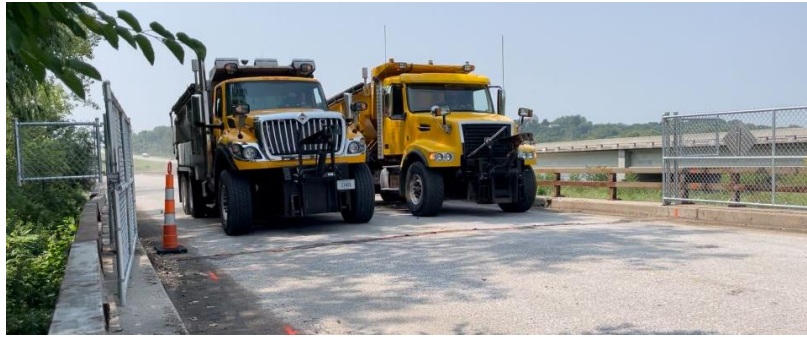
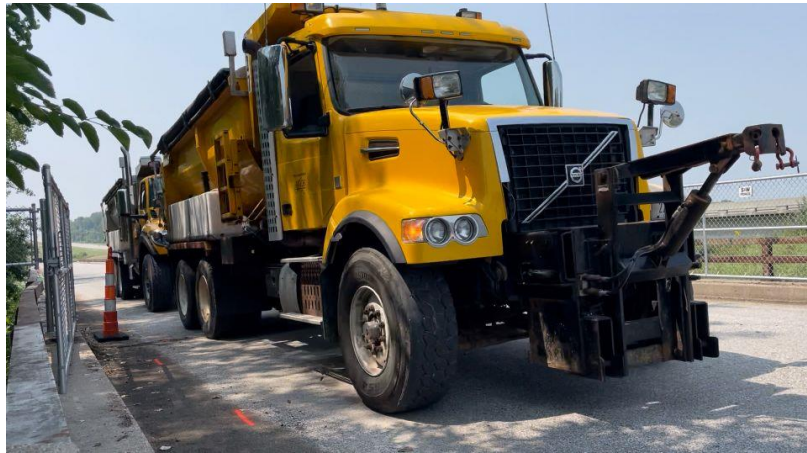
Figure 4.5. Example of side-by-side and back-to-back truck passing load test.

(a) side-by-side truck passing

(b) Back-to-back truck passing

In this research and to quantify the bridge behavior under traffic loads, two triaxial trucks with known weights passed through the bridges many times with previously defined speed and spacings. Figure 4.5 shows the two trucks passing through the bridge. The test trucks were 3-axle vehicles with different weights, where one truck denoted as number one was 50,400 lb, and truck denoted as number two of 30,560 lb. Figure 4.6 shows the two trucks used for this bridge loading test at the NOBL West bridge at Yutan. The acceleration values were recorded for every single truck pass, as a function of time, and for both two trucks as side-by-side and back-to-back in one or two different traffic lanes. The tests were repeated for approximately sixty times for each of the bridges with various speeds ranging from 5-60 miles per hour. The load combination for NOBL North bridge is shown in Table 4.1. Load combinations related to the other two bridges can be found in appendix B, which closely mimics that of the NOBL North bridge.

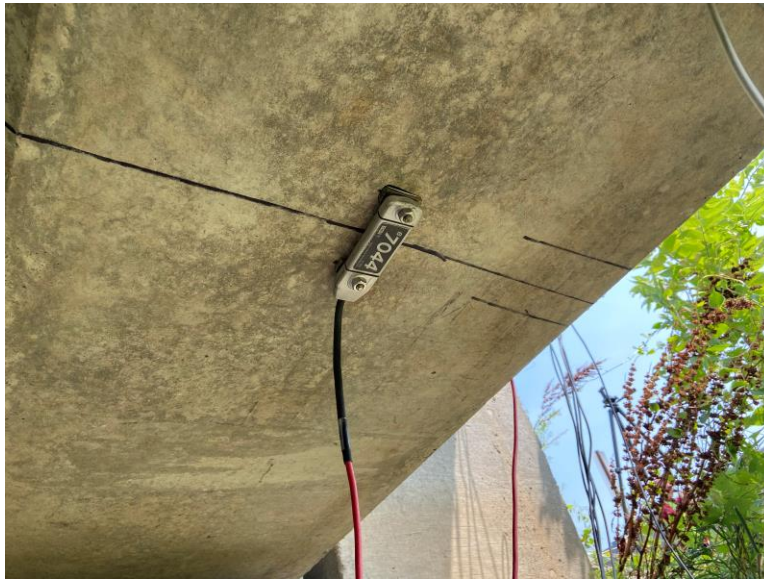
Figure 5.5. Strain transducer attached to the bottom flange of girder.

A total of forty-four (44) strain transducers were attached at the four selected cross-sections. Figure 5.4 shows the strain locations on the girder and the bottom of the concrete deck. On each girder, strain transducers were attached to the center of the bottom flange. Additionally, girder web strain transducers were installed to determine the neutral axis and evaluate the bridge behavior of non-composite and composite sections. A strain transducer was attached to the bottom of the concrete deck 2 in. from the side of the top flange of the center girder (G3) for each cross section. Transducers were attached to the concrete with adhesively bonded metal tabs, as shown in Figure 5.5.

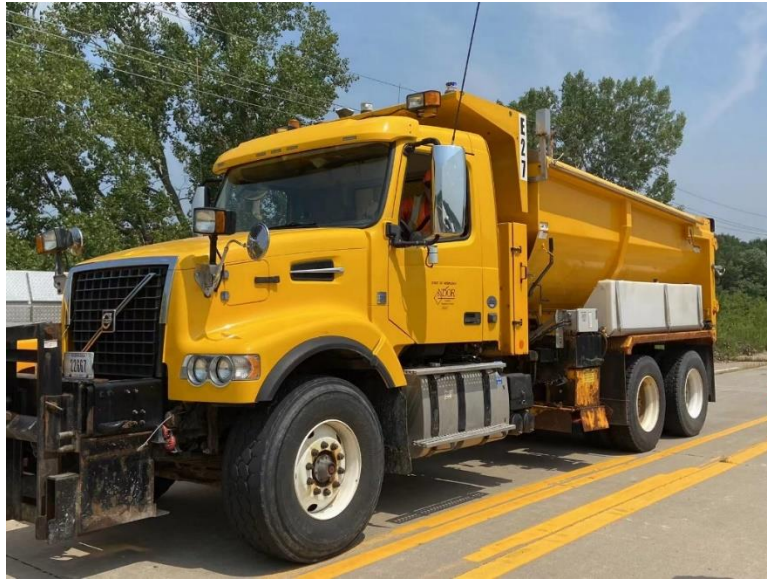
Figure 5.6. Load test truck A.

Two 3-axle trucks (Legal Type 3 vehicles) were provided by NDOT for NOBL North loading. Figure 5.6 shows one of the trucks used in the load tests. Only total truck weight was supplied, not weight by axle or wheel, so each test truck axle load was assumed to be proportional to the Nebraska Legal Type 3 configuration. Girder distribution factors were evaluated by driving trucks across the bridge at various transverse locations, as illustrated in Figure 5.7. A total of 32 load tests were performed, with various combinations of one or both trucks, truck directions, truck transverse positions, and speeds from crawling (approximately 5 mph) up to about 60 mph. Refer to Appendix C for additional details.

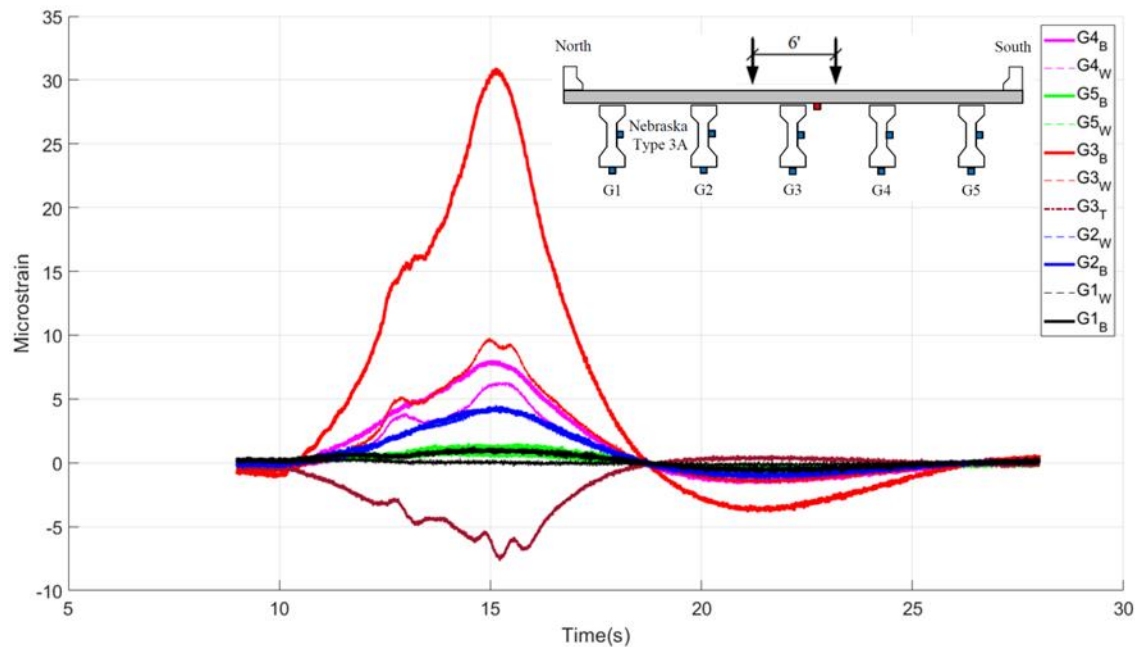
Figure 5.8. Strain transducer results at 0.4L end span for one truck A at the center from east to west.

Transducers located at 0.4L of the east end span measured the positive moment response and were used to quantify GDFs. As truck A crawls at approximately 5 mph from east to west at the center, Figure 5.8 shows the measured values for the transducers at 0.4L of the end span. Time (seconds) is shown on the x-axis, and microstrain ($\mu\epsilon$) is shown on the y-axis. As expected for Run 1, peak strains occurred on the bridge's middle girder (G3). At the bottom of G3, the maximum strain value is about +32 $\mu\epsilon$. Because of the intended

transverse symmetrical load position, the strains for G2 and G4 should be similar. However, G4 has greater strains than G2 presumably due to a slightly off-center transverse truck positioning.

Unexpectedly, the test strains at G2 are similar at the bottom flange and the web, implying axial rather than flexural deformation. This result does not seem reasonable, yet the recorded strains are nonzero and outside the noise band, suggesting that the data is real and not spurious noise. This abnormality may reflect torsional influences on the girder cross-section strains that could have obfuscated the primary flexural response. In situations where loads travel along the center of the bridge width, exterior girders G1 and G5, as expected, carried a lesser load. Refer to Appendix C for additional details.

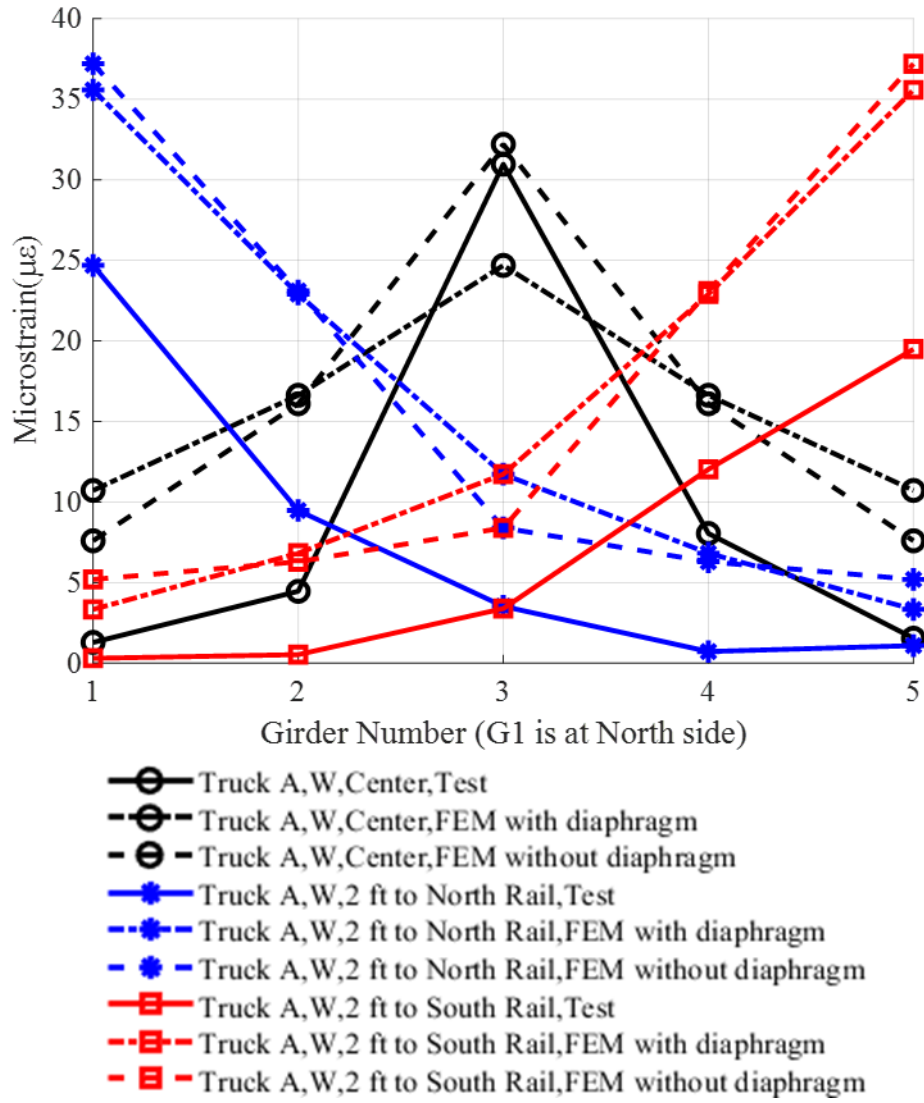
Figure 5.9. Positive strain at 0.4 L of east end Span, west direction loading.

Possible reasons for the lower strains observed in load tests than in FEMs include partial fixity conditions at supports (although test data did not indicate this effect to be significant for this bridge), higher concrete moduli of elasticity than expected according to AASHTO, and potential stiffening from barriers. Figure 5.10 shows that the load test GDFs at 0.4L of the end span were more similar to the results of the FEM without diaphragms, which indicates that the diaphragms are not acting with transverse flexural continuity through the girders. On close inspection of the NOBL North bridge at Omaha drawings, the diaphragms are found to only interact with the girders through compression bearing. Reinforcing at the top of the diaphragms ties the diaphragms to the deck, but no reinforcing crosses the interfaces of diaphragms and girder flanges or webs. Therefore, complex torsional effects and compression-only contact interactions may also be influencing both flange and web strains that are currently unaccounted for in the 3D FEM models.
